**AIRCRAFT SHELTER EXPLOSIVES
QUANTITY-DISTANCE EVALUATION,
CONCRETE SKY, PHASE IXB**

TECHNICAL REPORT NO. AFWL-TR-71-65

July 1971

AIR FORCE WEAPONS LABORATORY

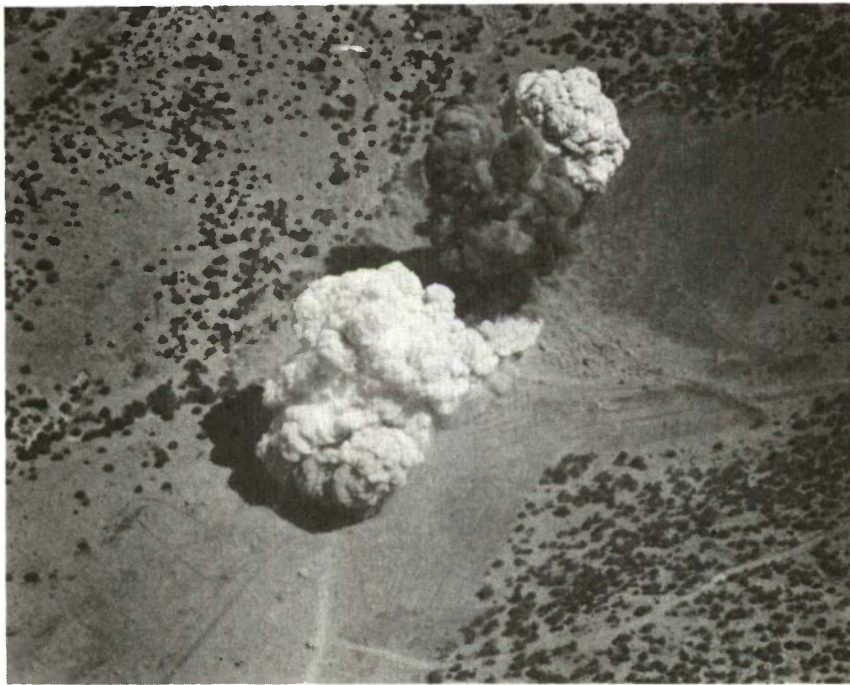
Figure 10. Aerial View of Detonation

Detonation of the munitions in the donor shelter and subsequent rupturing of the fuel tanks on the donor aircraft and explosion of the fuel resulted in large fireballs approximately 400 feet long, which jetted out the front and back of the donor shelter (figure 10). After the smoke and fireball lifted, it was immediately revealed that the two acceptor shelters were still standing; hence no propagation of the explosion occurred. The following paragraphs in this section describe the failure of the donor shelter, damage to acceptor aircraft and shelters, fragment data, and pressure data.

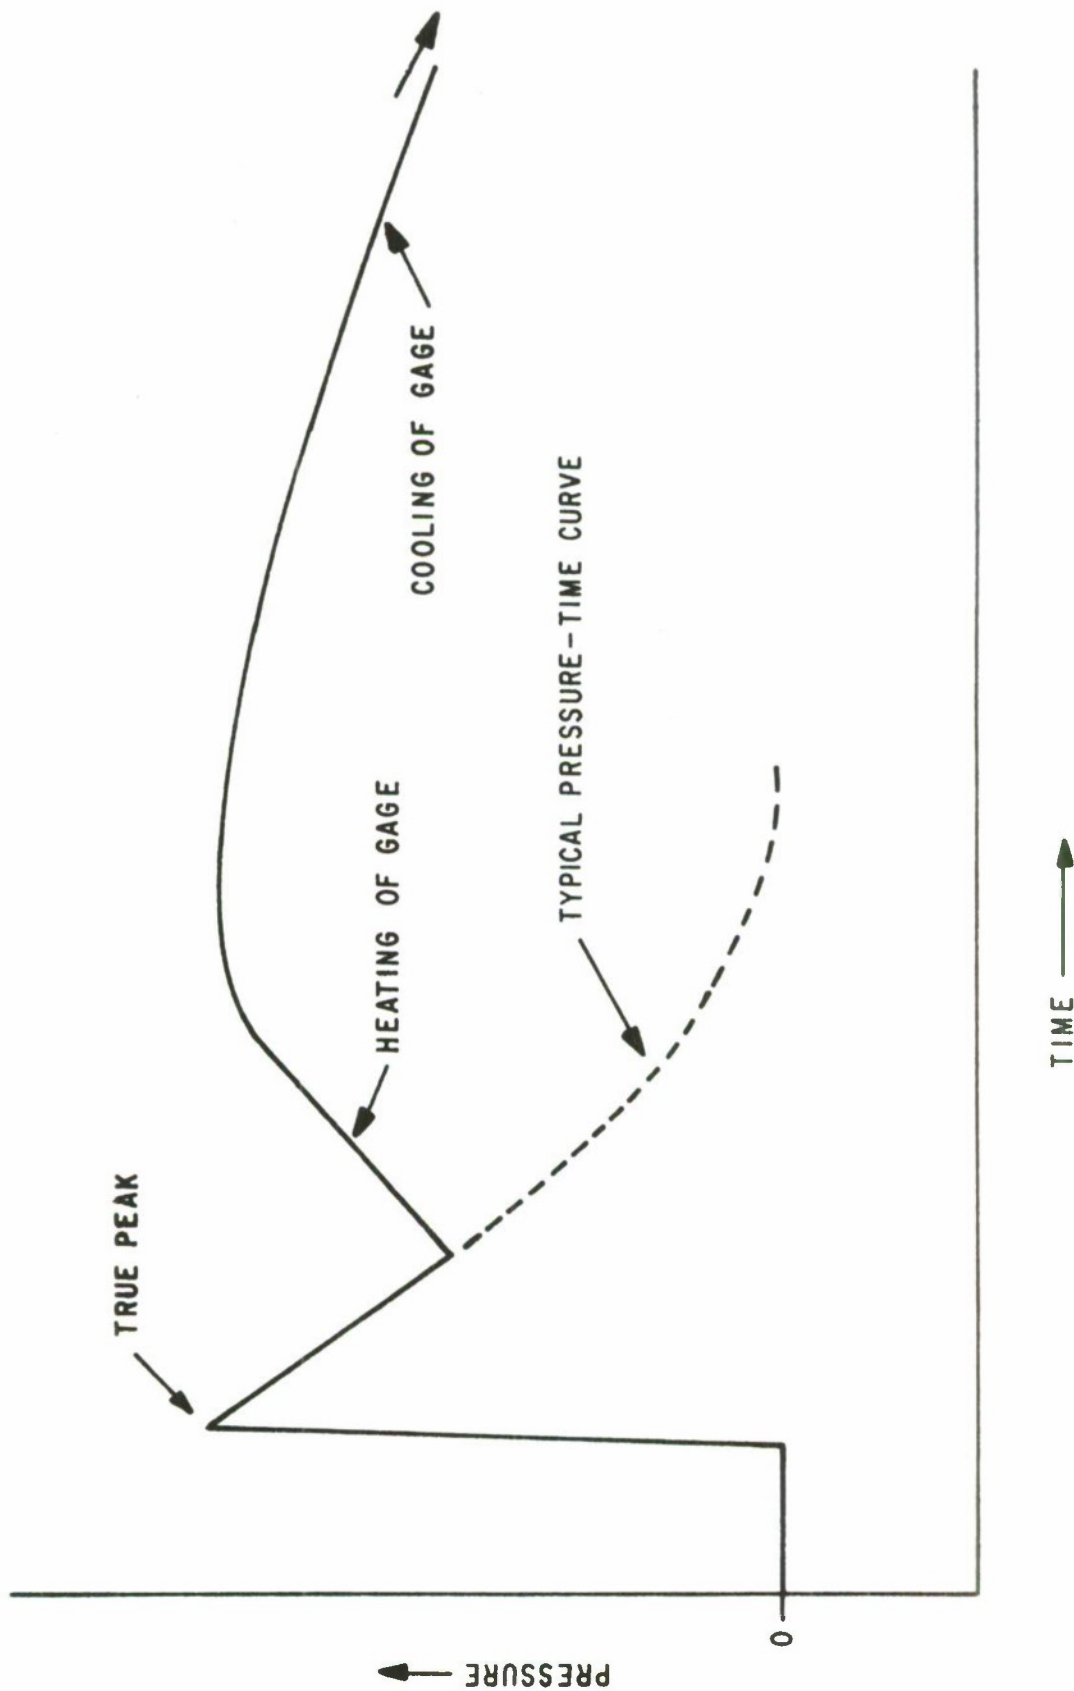
Figure 21. Schematic Representation of Data from Norwood Gages

Free-field gage 13 and in-shelter gages 1, 2, 5, 6, 7, 11, and 12 exhibited behavior that was considered nontypical and probably at least partially erroneous. Rather than a triangular pulse (discounting reflections), these gages produced data traces with several distinct regions. After an initial peak and the beginning of a normal fall-off, the pressure began to rise toward a second peak. This is followed by a long gradual decay back to ambient pressure. This is shown schematically in figure 21. It is felt that the initial peaks were representative of the true peak pressures at the corresponding locations. The second peak and long-duration decline to ambient pressure apparently were caused by rapid heating and subsequent cooling of the pressure gages after passage of the initial shock wave. All gages that displayed this effect were of the same type and model number, and were calibrated by the manufacturer to be linear in the temperature range from -65° to $+300^{\circ}$ Fahrenheit. These gages were all very close to the firball (gage 13 was engulfed by it) and were exposed to extreme temperatures. No data was available from the manufacturer to indicate the effect of such temperatures, but it is presumed that heat was the cause of the unusual shape of the pressure curves for these gages. Further, the diaphragm on this model gage was mounted flush on the surface of the instrument in a more exposed position than the remaining gages which had recessed diaphragms.
